# Ripley

## Annual and Summary Report

*For the 2019 Operating Year*

Veolia Water  
100 Cove Road  
Goderich, ON  
N7A 3Z2  
Author: Nancy Mayhew

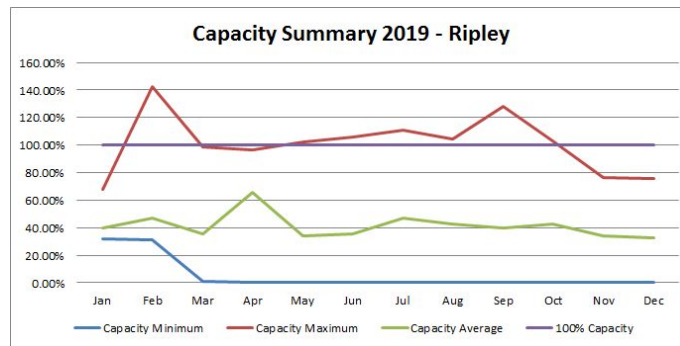
Figure 2

Table 17 - Total Volumes of All Well Supplies

Location (Well Supply)	Total Volume for 2019 (m <sup>3</sup> )
Ripley Pumphouse	121,684.82
<b>Total Rated Capacity, PTTW (m<sup>3</sup>)</b>	<b>315,360.00</b>
Overall Operating Capacity, Actual %	38.6%
